## **HISTORIC KEENE LODGE AND COMMUNITY CENTER RESTORATION AND MAINTENANCE OF EXISTING BUILDINGS**

# **Historic Keene Lodge and Community Center Restoration and Maintenance of Existing Buildings**

# **Historic Keene Lodge and Community Center Restoration and Maintenance**

## **Project Overview**

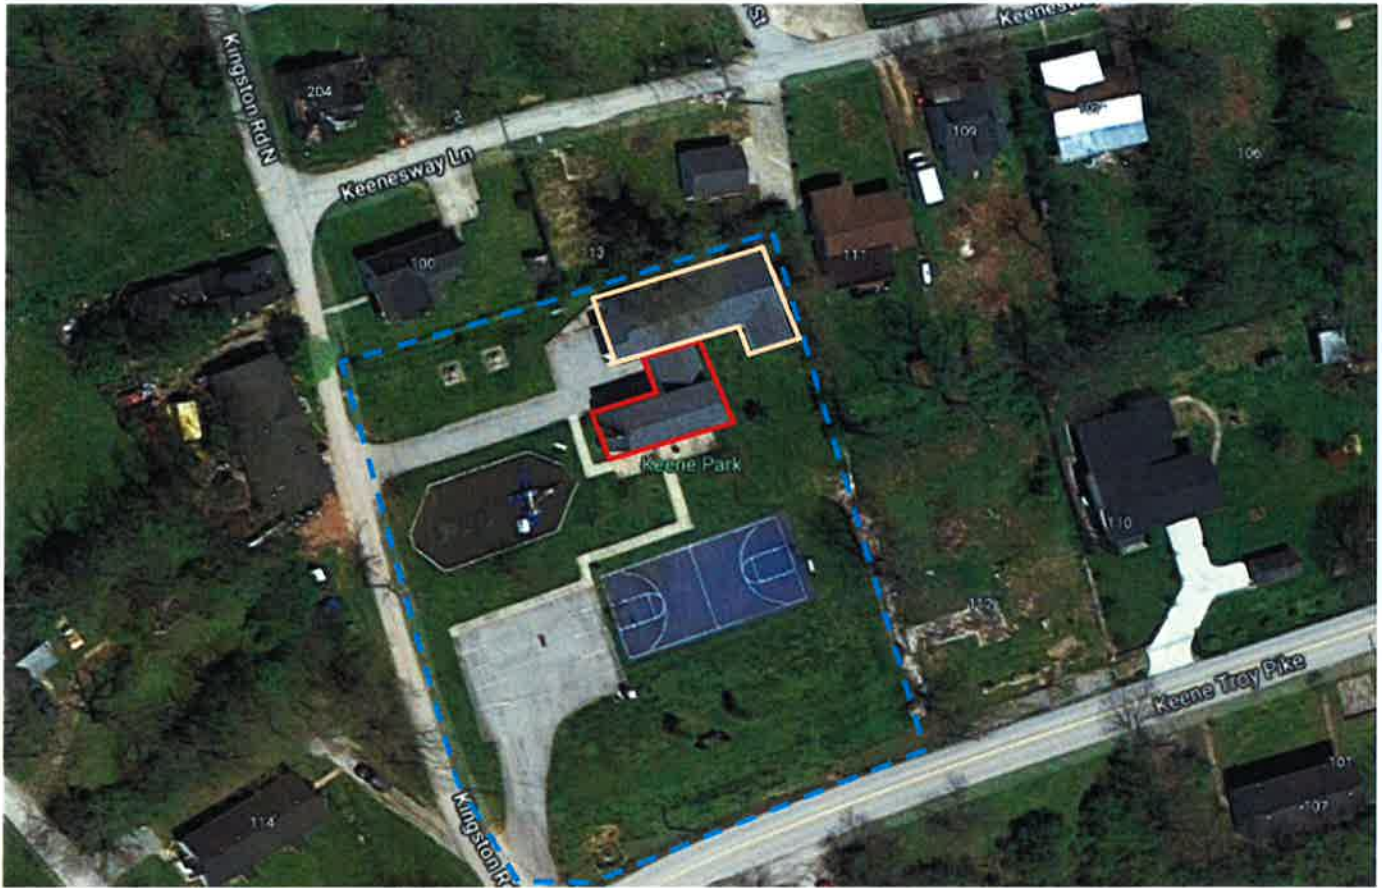
## Aerial Overview

- Historic residential element of the property.
- Modern detached rear building.
- Approximate property boundary.

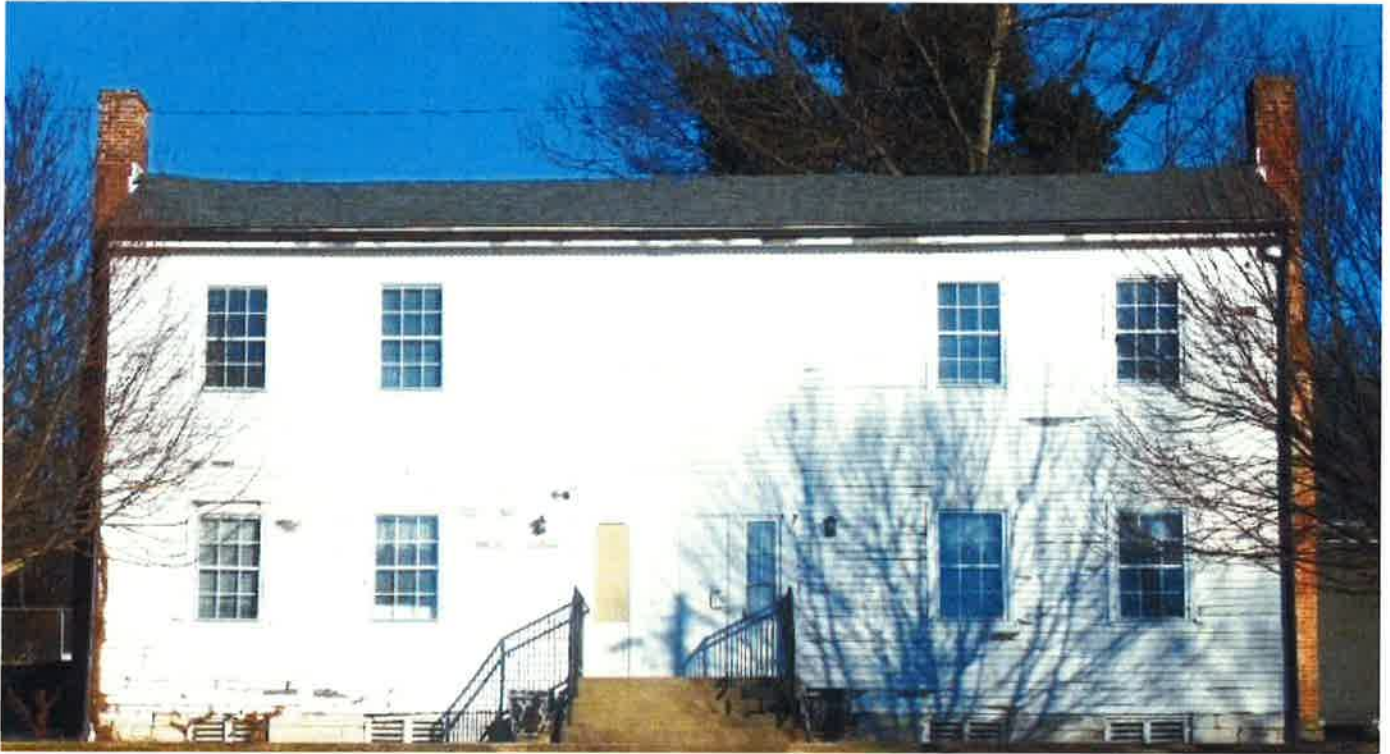
**Front Elevation View Facing North**

**General Description:** This is a rectangular structure of combination-framed construction with a rear ell addition. The house was likely built or altered from its original form in the last quarter of the 19th century. The house is a single pile, central passage plan with a total of 5 bays (WWDWW). The roof is clad in replacement asphalt shingles with some irregularities in the ridgeline that demonstrate age related settling of the roof system over time. There are exterior brick chimneys that are free-standing structures on both gable ends. The eaves, gutter system and dental fascia along the cornice have been rebuilt with modern materials. The house is clad in replacement clapboard siding and the windows appear to be non-historic replacements. That are 6/6 double hung wood sashes. The upper (center) elevation appears to have accommodated a porch roof or "sleeping porch" in the past and the front entrance has been unsympathetically altered with modern materials that include a poured concrete stair structure (see next page for examples). The house sits on a dry laid stone foundation that appears to be non-continuous with the rear ell of the structure. The front-facing foundation stones are scored while the remaining stones are unfinished and dimensionally irregular.

Conspicuous area on the front façade, which appears to have once had a more substantial entry and second story features. It is not know at this point when those elements were removed.

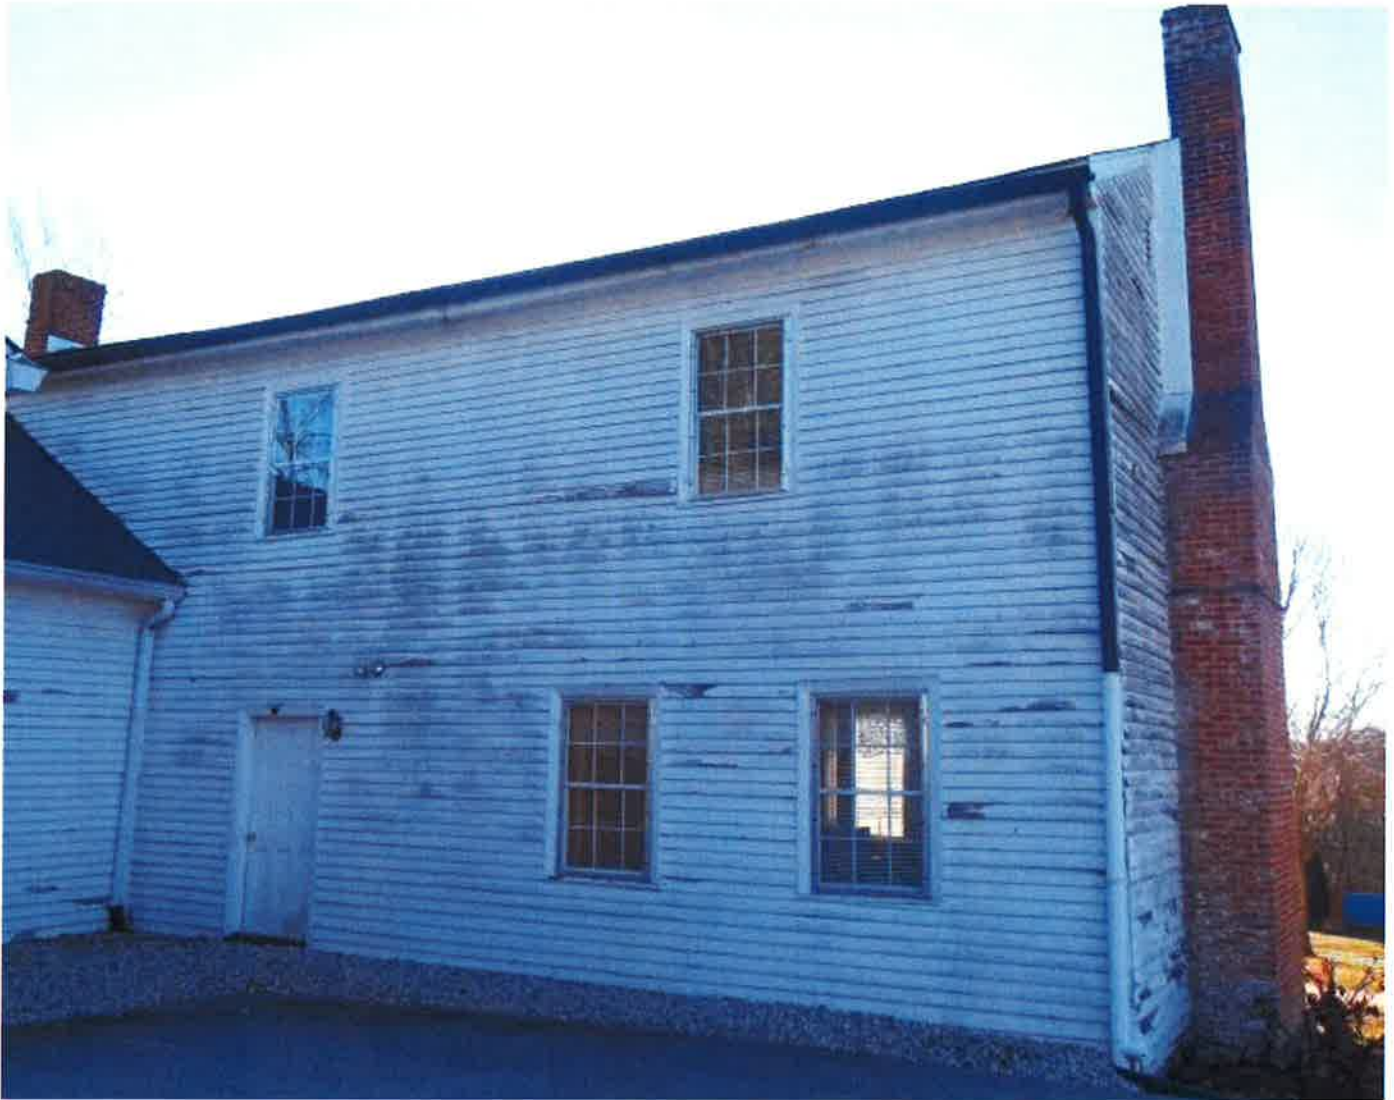
**View Facing South**

The rear elevation introduces an interruption in the symmetry of the house. The rear door is a modern replacement and is inline with the central passage corridor. The interior has been unsympathetically altered from the original design intent, and it is hard to know the extent of alterations to the current fenestration pattern. All the windows appear to be modern replacements.

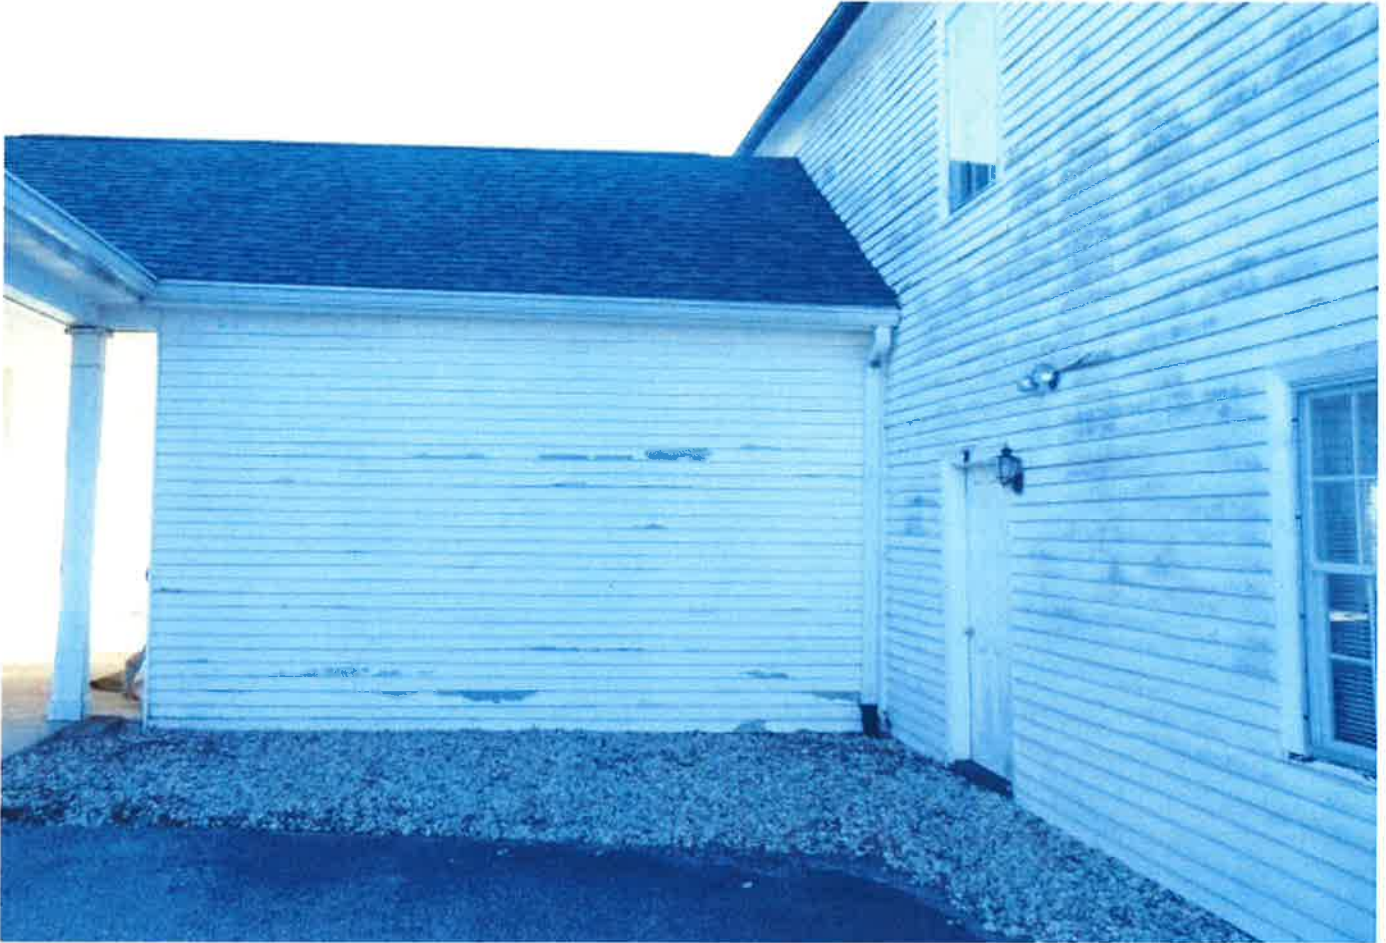
**View Facing East, Rear Ell**

The rear ell appears to be a historic addition to the original house plan. It is fully enclosed and presently features a stairwell system to access the second floor. The roof structure appears to have been modified at the time the detached rear addition was installed. The foundation is dry laid stone and non-contiguous with the primary foundation of the house. Presently there does not appear to be a chimney or other fire box configuration associated with the ell.

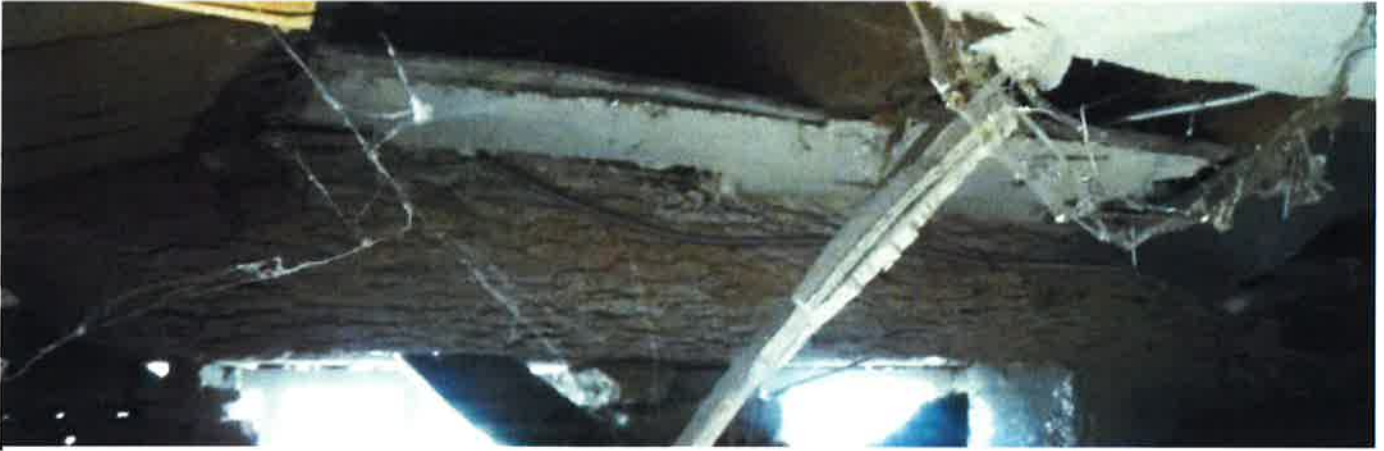
Rough Log center beam for flooring system indicates perhaps two possibilities. 1. an earlier log structure occupied the present footprint or 2. The house was originally built as a combination-framed structure.

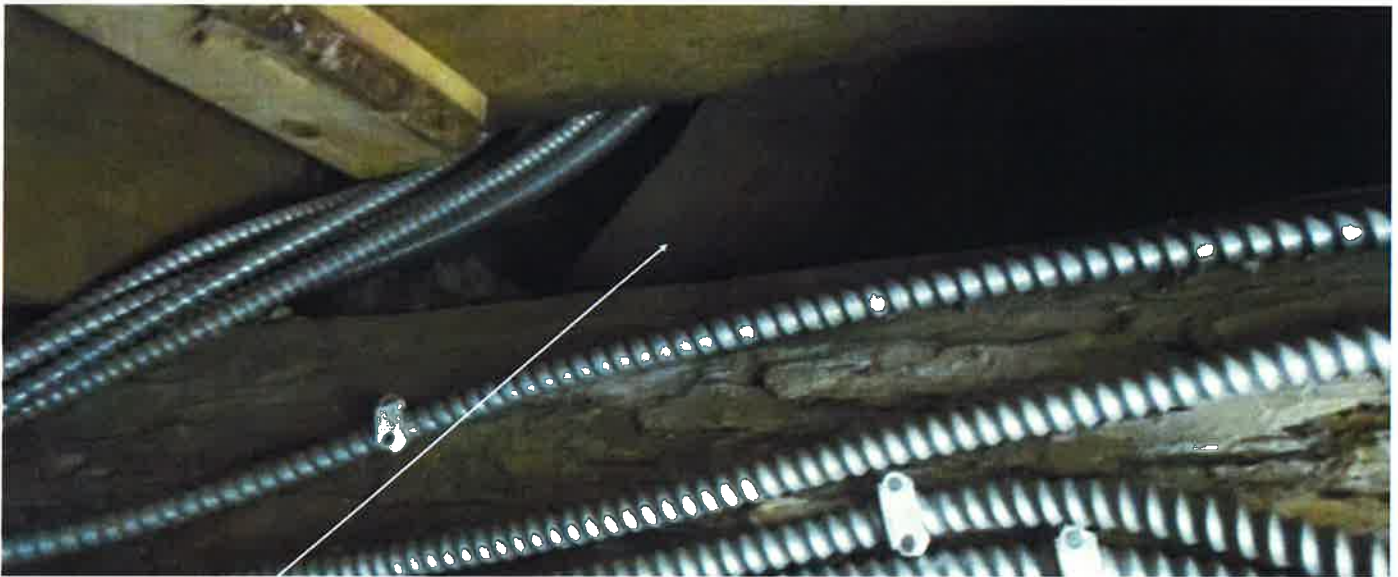
Heavy timber corner (or down) bracing is evidence of a combination-framing system that integrated with lighter (less bulky) wall studs.

The structural system of the historic house appears to be a “combination-frame”. A typical combination frame system will transition from bulky foundational framing members to a light-weight wall structure made up of full-span studs with a center ledger that carries the second floor joist system. In effect, the house gets “lighter” as it goes up.

It has been observed that the house uses heavy timbers (logs) to form part of the sill and center beams. The logs support the floor joists, which span the width of the floor and rest upon the log sill and center beam. The floor joists are heavy, milled lumber of regular dimensions and equal spacing.

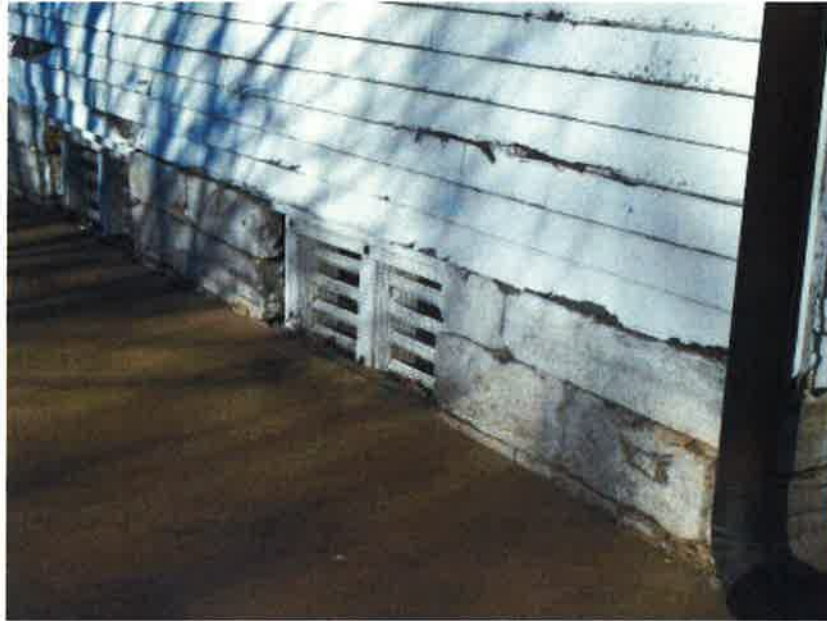
The foundation is continuous dry-laid cut stone. The front-facing stones are scored as a means of creating a finished surface.

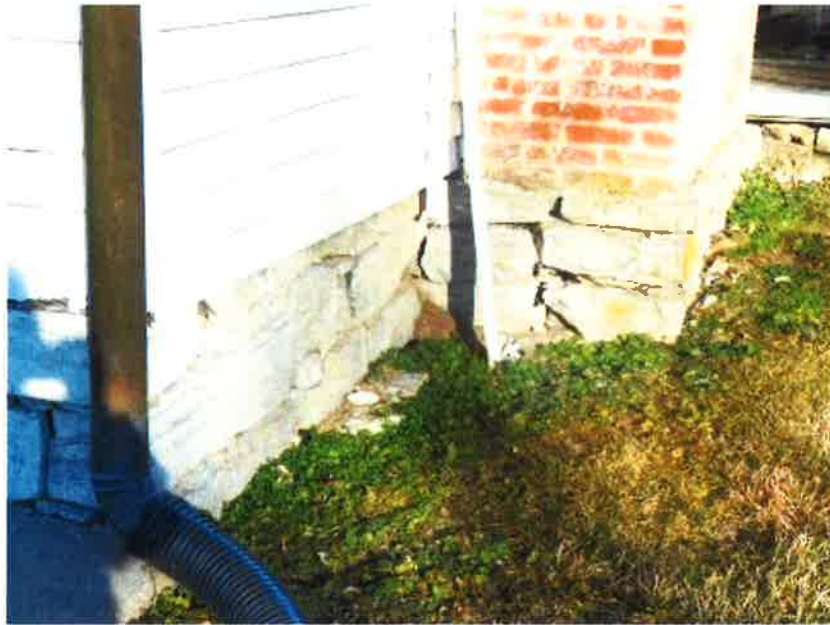
The remaining foundation stones are dry-laid and irregular in their shape and dimensions.

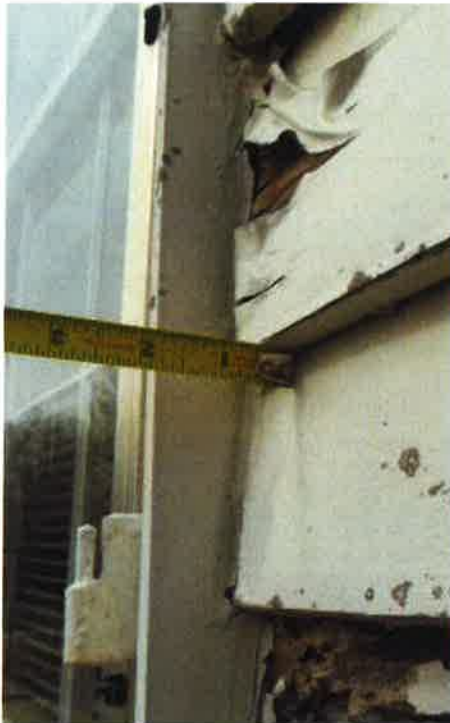
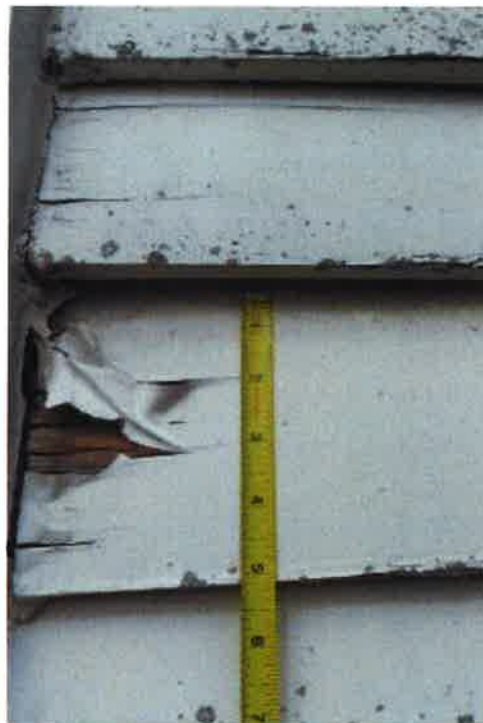
***Approximate Dimensions of Existing Siding in Profile***

1. Based on field observations, the present siding is not original to the house but it does serve as a guide for what materials and workmanship were customary to the original period of construction. Therefore, it is proper to use a wood clapboard material as a replacement, which is what occurred in past efforts to renew the siding materials.

A= 5" B= 2" C= 1/2" D= 3/8"

2. The replacement siding should match (as close as possible) the dimensions of the existing siding and be installed using present day industry standards of workmanship. The estimate should take into consideration re-siding the entire house with associated trim elements throughout—including the trim around the windows.

**\*\* Please include an alternate quote to replace the siding using Hardie Plank instead of wood siding.**

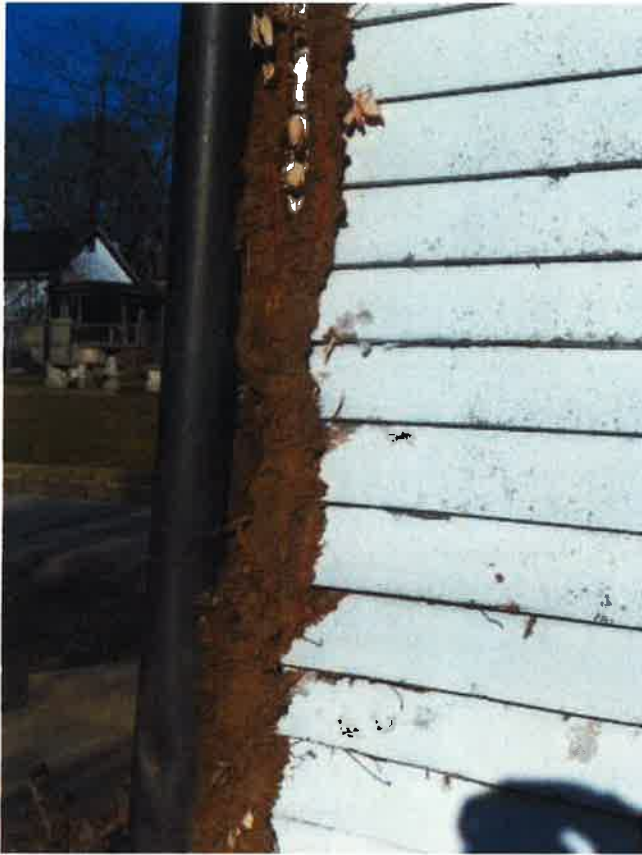
Remnants of vines that remain attached to the siding.

3. There are structural intrusions remaining from some vines that established themselves onto the house. Any such obstructions should be thoroughly removed as part of the process for re-siding the house.

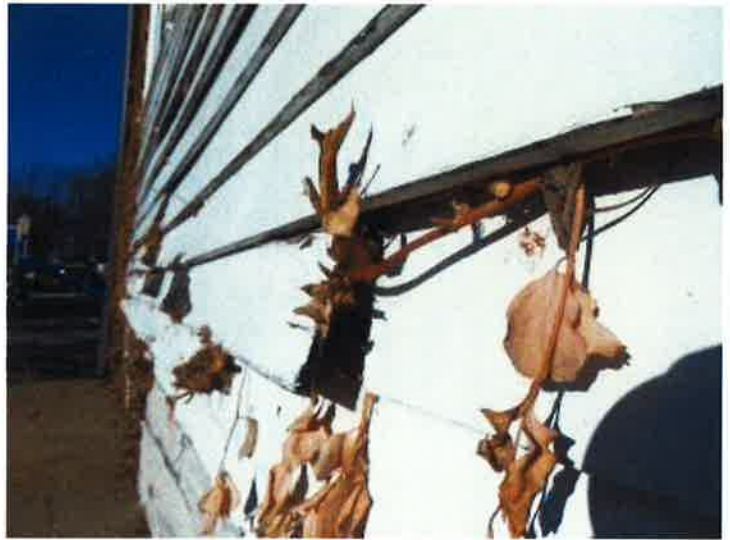
Encroachments behind the existing siding.

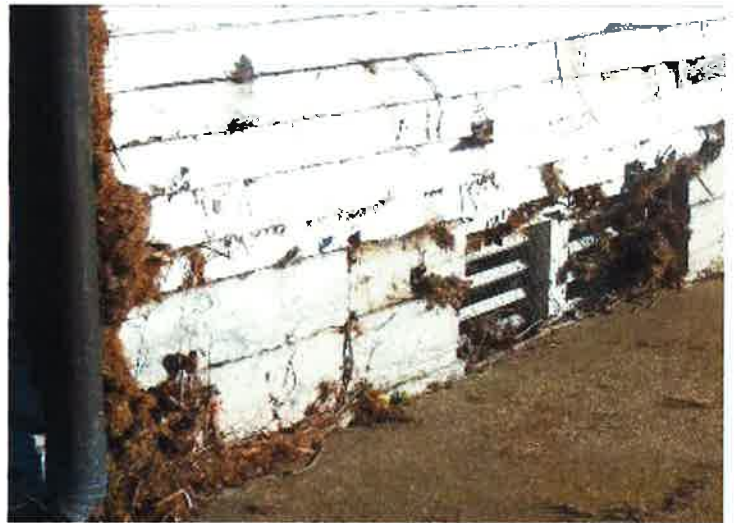
Additional encroachments around foundation and vents.

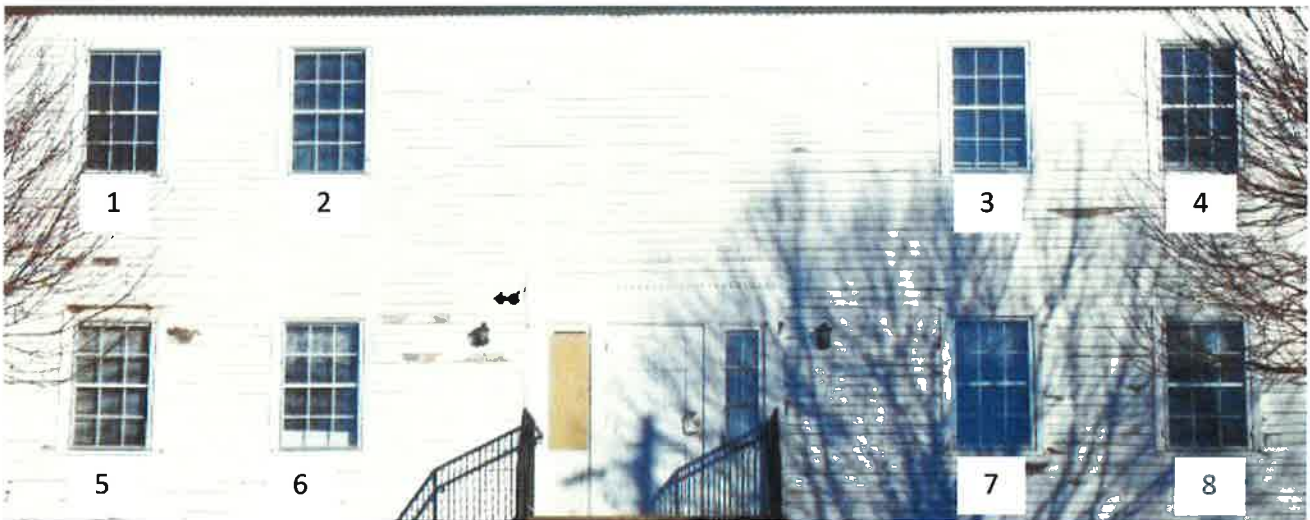
Front Elevation Windows.

There are a total of 13 windows. Each window is double hung, wood sashes, with raised mullions in a 6/6 pattern. Each of the windows are modern replacements and most appear to be in need of maintenance and painting. However, certain windows show a lot of decay around the trim, sills, and potentially the window jambs. It is possible that some windows may need to be replaced.

Window #	Comments
1	In-place maintenance
2	In-place maintenance
3	In-place maintenance
4	In-place maintenance
5	Remove and repair framing rot, perform maintenance on window, replace trim
6	In-place maintenance
7	In-place maintenance
8	In-place maintenance
9	In-place maintenance
10	In-place maintenance
11	Issues with the sill, may need to be removed for repairs, then reinstalled and replace trim
12	Window is tilted, remove to correct tilt, reinstall, replace trim
13	In-place maintenance

1. Repaired in place
2. Removed, repaired, and reinstalled
3. Combination of Repair and Replace
4. Replace all windows (show as bid alternate #2).

Nevertheless, all the windows should be functional and in an excellent state of repair once completed, including paint and repairs to mullions. Therefore, the bidder should perform an assessment and estimate for the treatment of all windows based on their individual needs. Give consideration to interior repairs/paint or trim elements that may be effected by work being done to the windows.

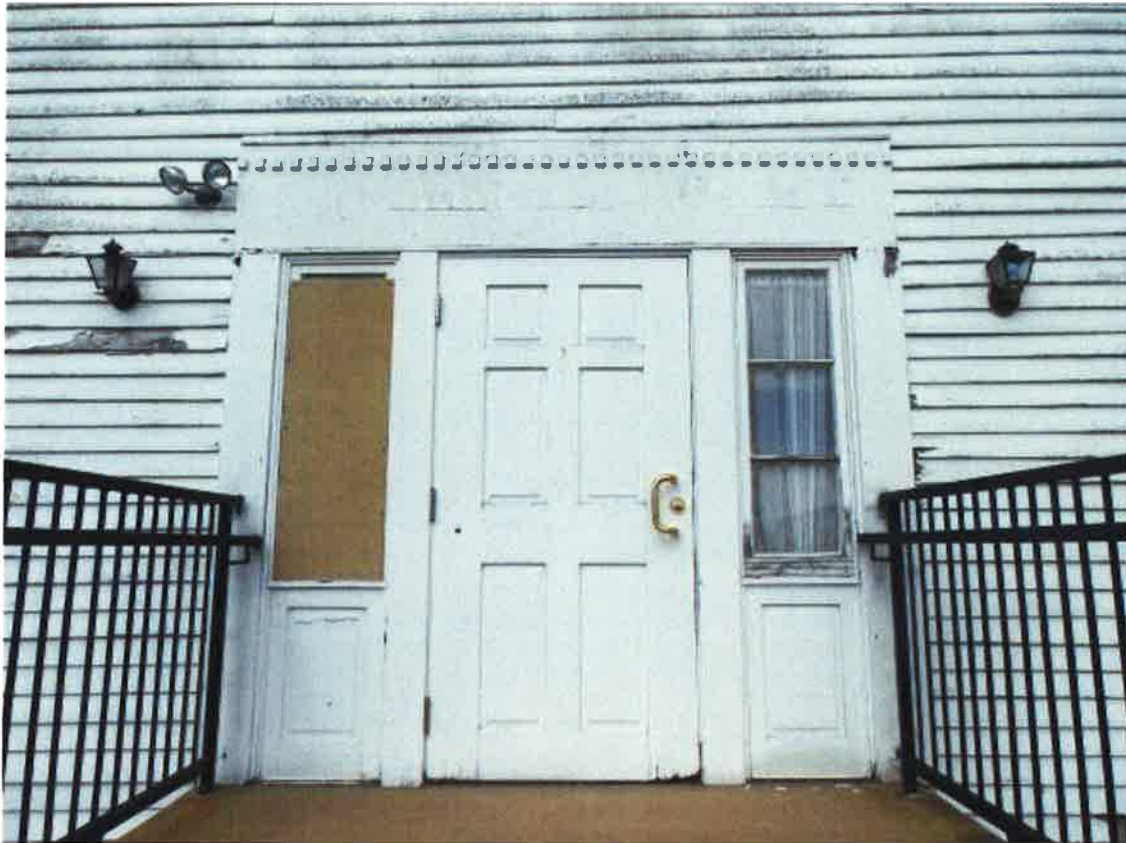
Front Entrance.

The Front Entrance is in need of several repairs and maintenance.

1. Assess the front door and recommend a treatment, including hardware.
2. Assess the side-lights and recommend a treatment. The side-light that is covered is due to broken glass, which needs to be repaired.
3. Assess door trim and recommend a treatment.
4. Assess coach lights (front and rear) and recommend appropriate replacements.
5. Evaluate the security lights front and rear and recommend a treatment.
6. Assess the rear door and recommend a treatment.

Consideration should be given to the interior trim around the doors with the aim of retaining what is presently there. Preferably, the least amount of intrusion is preferred.

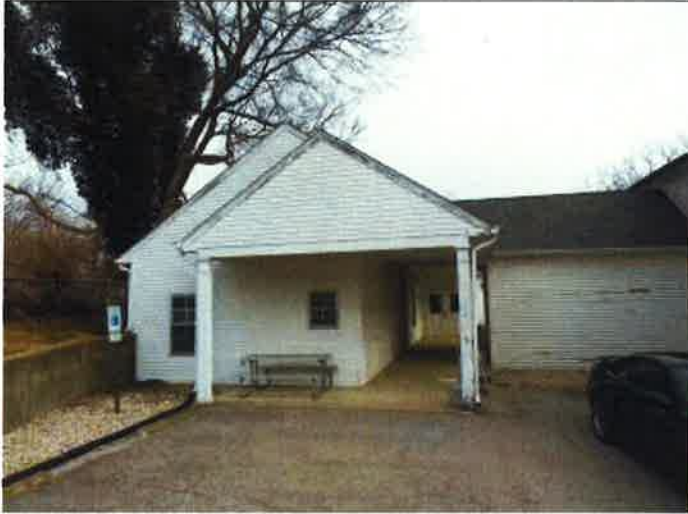
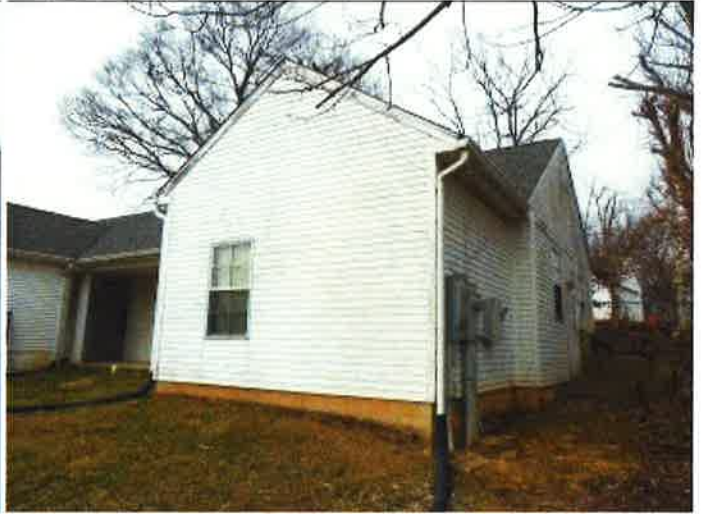
Front Entrance Facing East

Oblique View Facing Northwest

This building is a modern structure that is in need of general maintenance. The property owner would like to have the entire exterior of the building painted the same color as it presently is.

1. Although it does not appear that any trim elements are failing, conduct an assessment and make any recommendations necessary.
2. All surfaces to be painted should be properly treated prior to the application of the paint.
3. Use a high quality long-lasting, durable exterior paint.

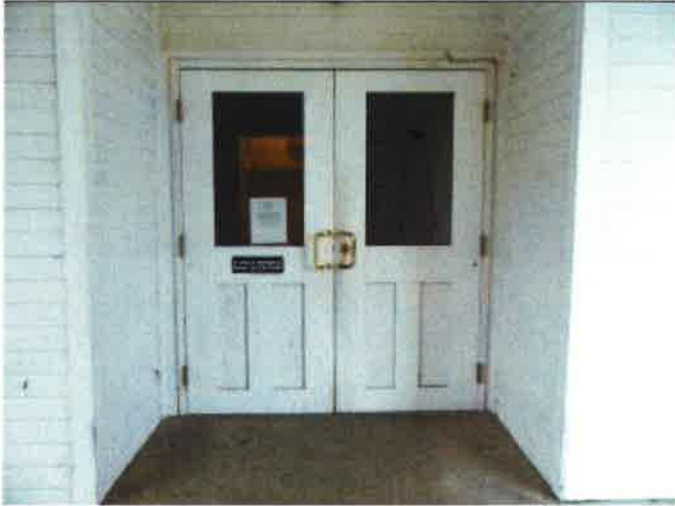
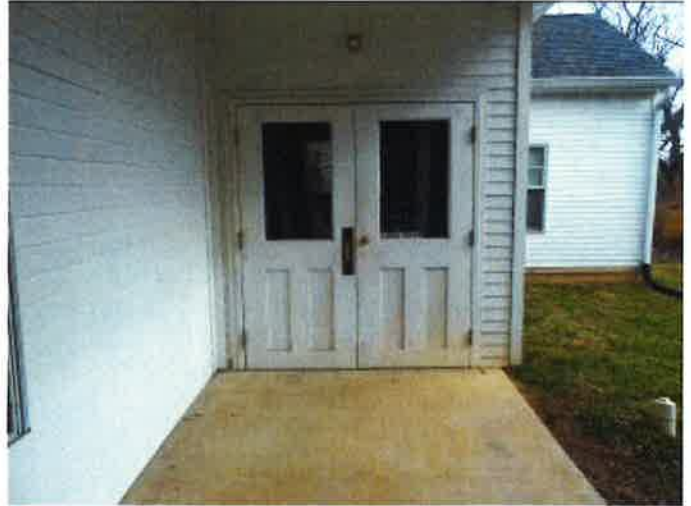
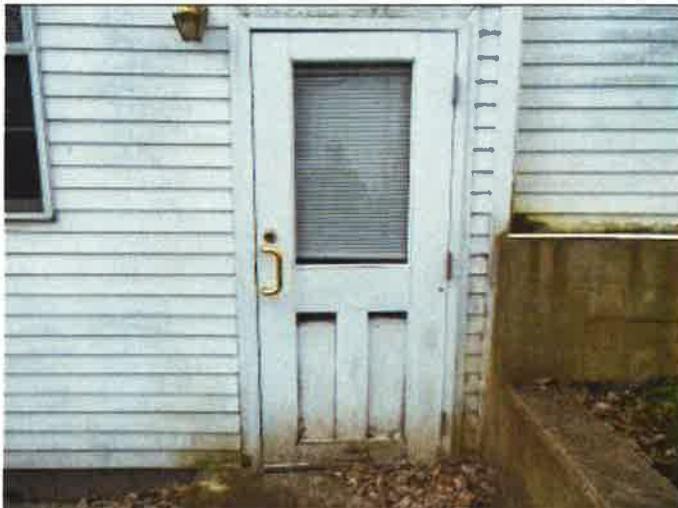
Front Entrance North

Side Entrance Facing East

Rear Door Facing West

The property owners would like to replace the existing double door entries with commercial metal doors. Likewise, the rear door needs to be replaced in like manner.

1. Consider replacing the doors only without replacing the door frame (if possible).
2. The replacement doors should use a “panic” exit device with appropriate exterior handles.
3. The doors should be painted once installed (color to be determined).
